Research Article

Soil Investigation of a Collapsed Building Site in Jos, Nigeria

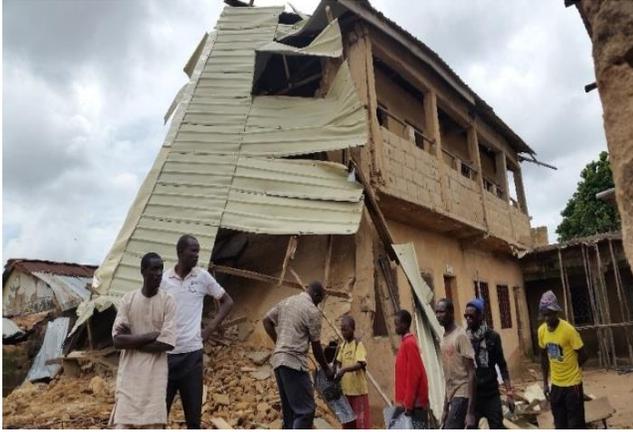
Plate 1 The partially collapsed areas

accommodation for teaching and learning for the pupils of the Bukuru community of Jos. The collapsed building is a 1-storey building viz; ground floor and first floor with a courtyard surrounded by existing adjoining classrooms and neighbouring houses. The Building Structure includes a hall, laboratory, and five (5) classrooms with a narrow single loading corridor at the first-floor level. Bordering the site eastwards, west, and southwards are buildings constructed with either laterite blocks or sandcrete. Lying north is an access road. As a result of many years of weathering and decomposition in a tropical environment, the soil on the site has transformed into laterite soil. The underlying rock seems to have decomposed, leaving a relatively hard material that has a grave texture mixed with some clayey materials.

- For pad foundation practice, it is recommended that the footing levels should be of a minimum depth of 1.5m below the natural ground. However, what was measured on site was less than 1.5m.

- The allowable/safe bearing capacity obtained from the site is 234.5 KN/m^2 which should have been adopted as the design allowable bearing capacity to be used for all foundation computations, but that was not used.

- The soil at the site seems to be made up of ground.
- Lastly, it is strongly recommended that the design and construction of the future superstructure at the site should be carried out in accordance with good engineering practice as embodied in recognized codes of practice such as the British Standard institutions BS 6031: 1981, Code of Practice for Earthworks and BS 8004: 1986, Code of Practice for Foundation.
